Town of Discovery Bay Old River Sanitary Outfall - Diffuser Section

Diver Inspection & Assessment

October 2022

By:
Underwater Resources, Inc.
866 Estabrook Street
San Leandro, CA 94577

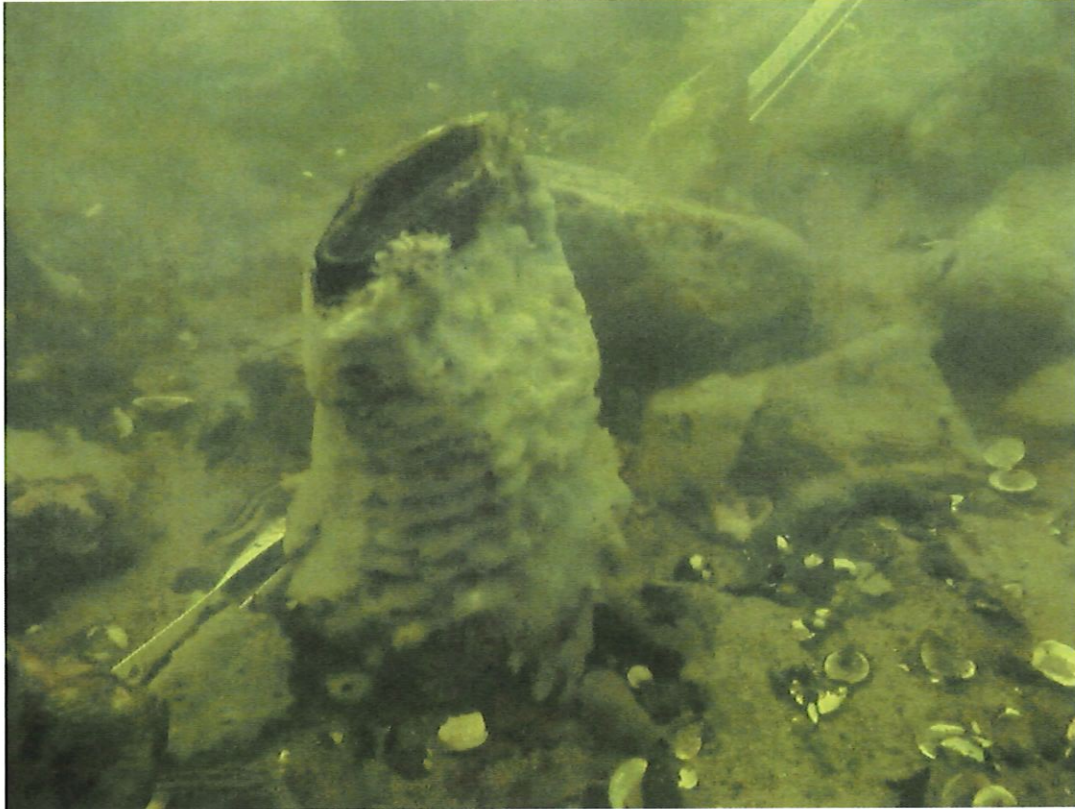
Photo 1 – Diffuser #1, Pre-Cleaning

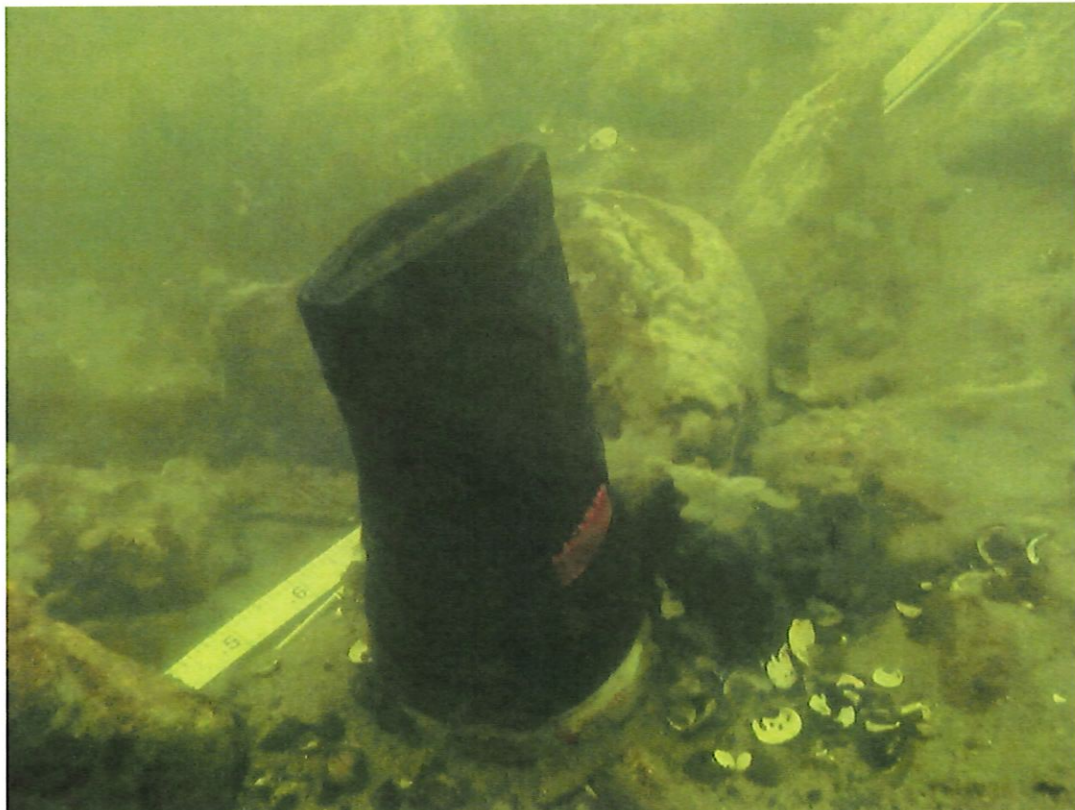
Photo 2 – Diffuser #1, Post-Cleaning

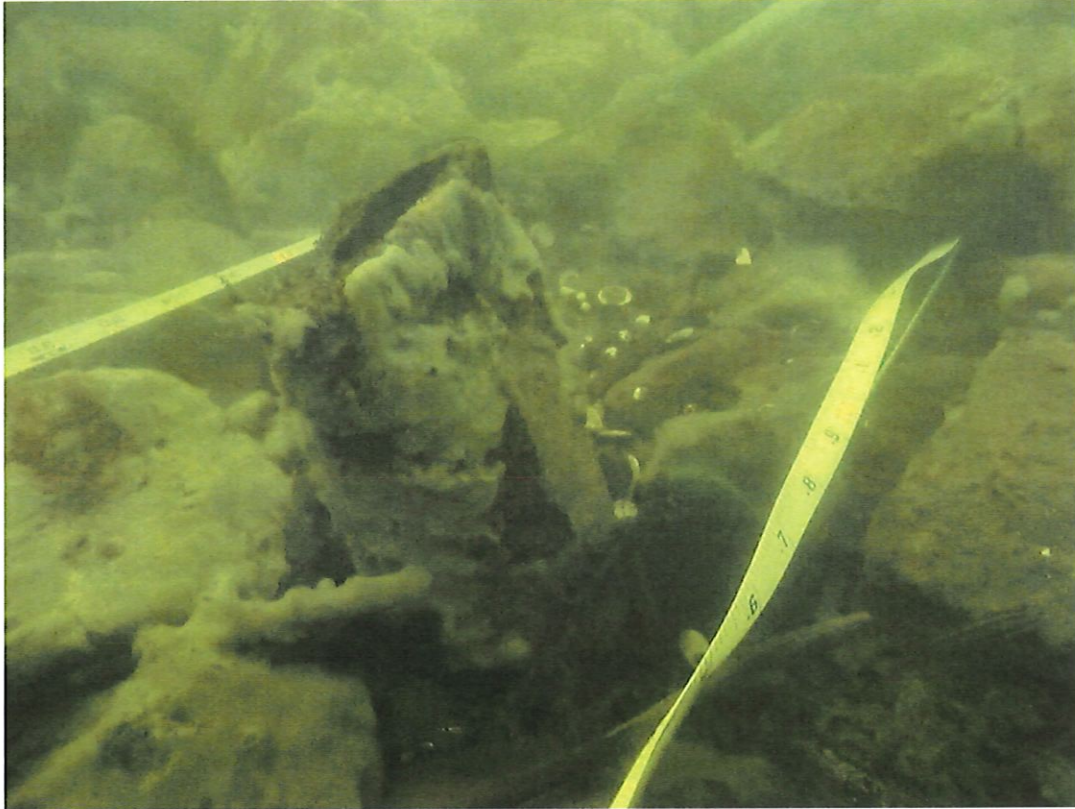
Photo 3 – Diffuser #2, Pre-Cleaning

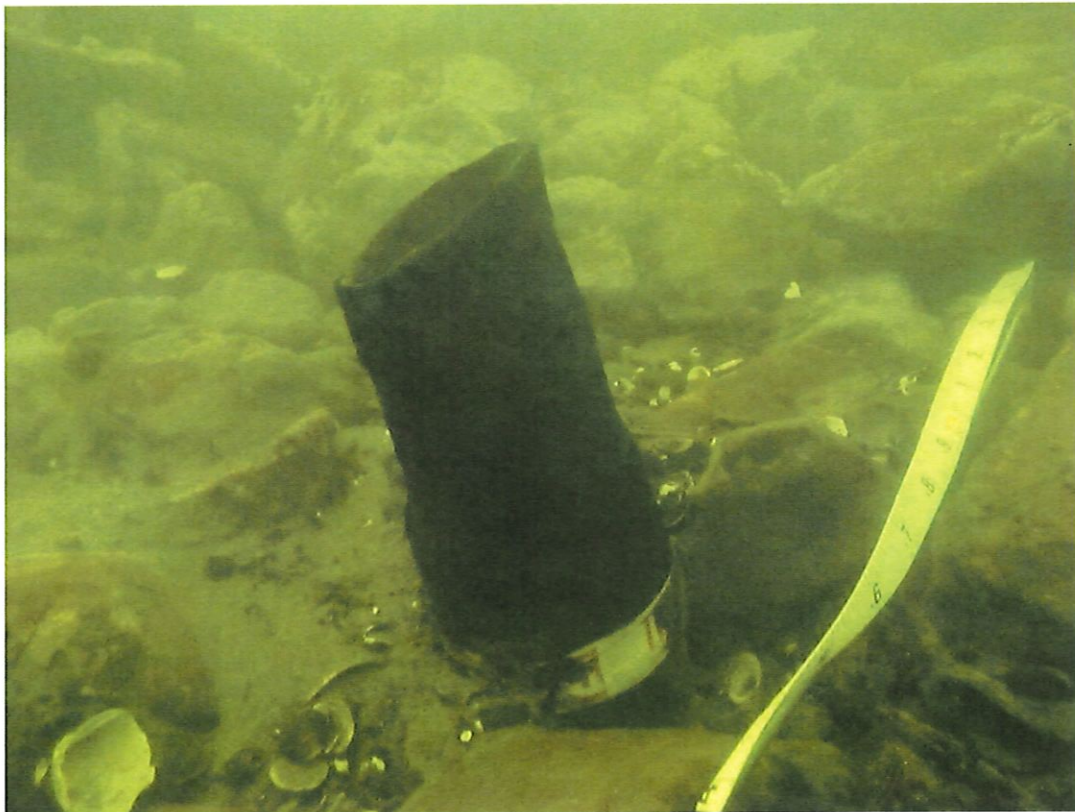
Photo 4 – Diffuser #2, Post-Cleaning

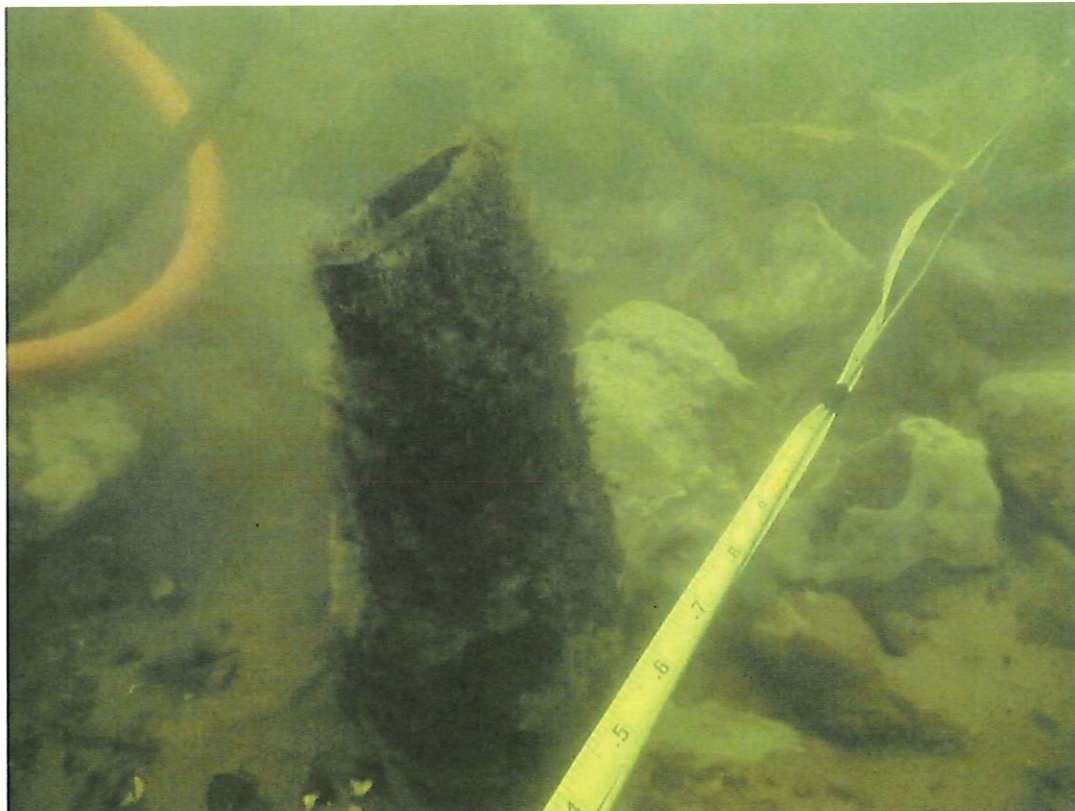
Photo 5 – Diffuser #3, Pre-Cleaning

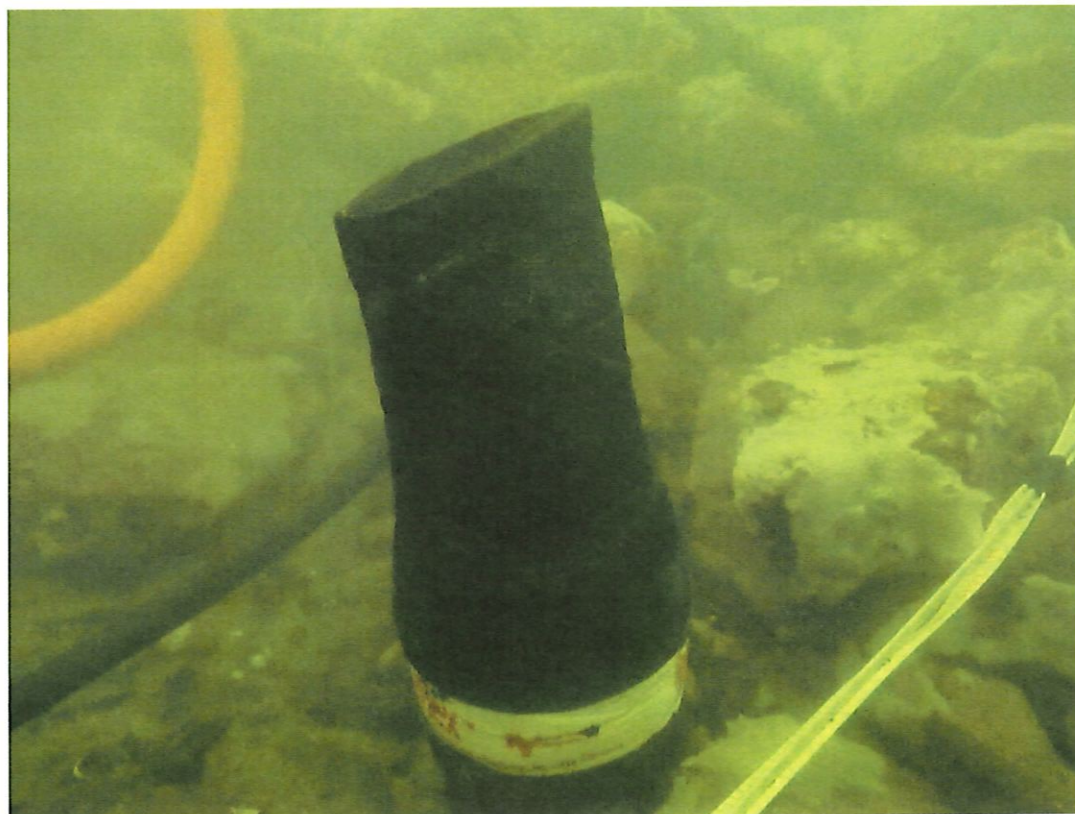
Photo 6 – Diffuser #3, Post-Cleaning

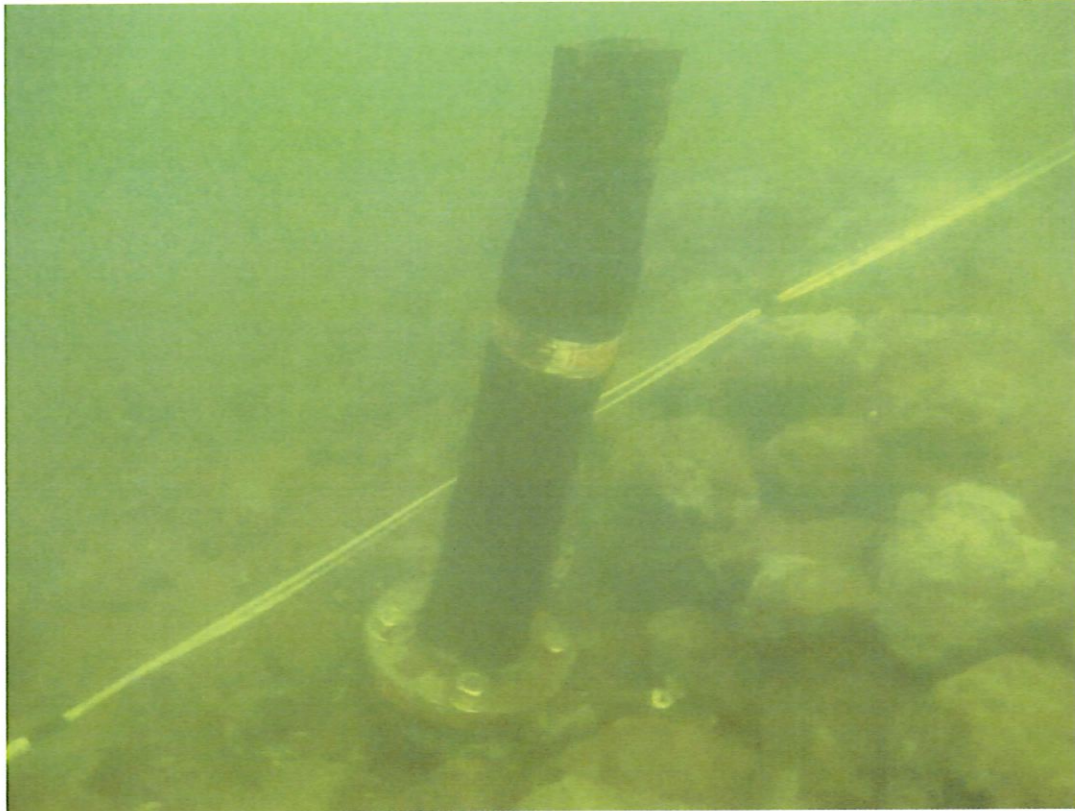
Photo 7 – Diffuser #12, Post-Cleaning

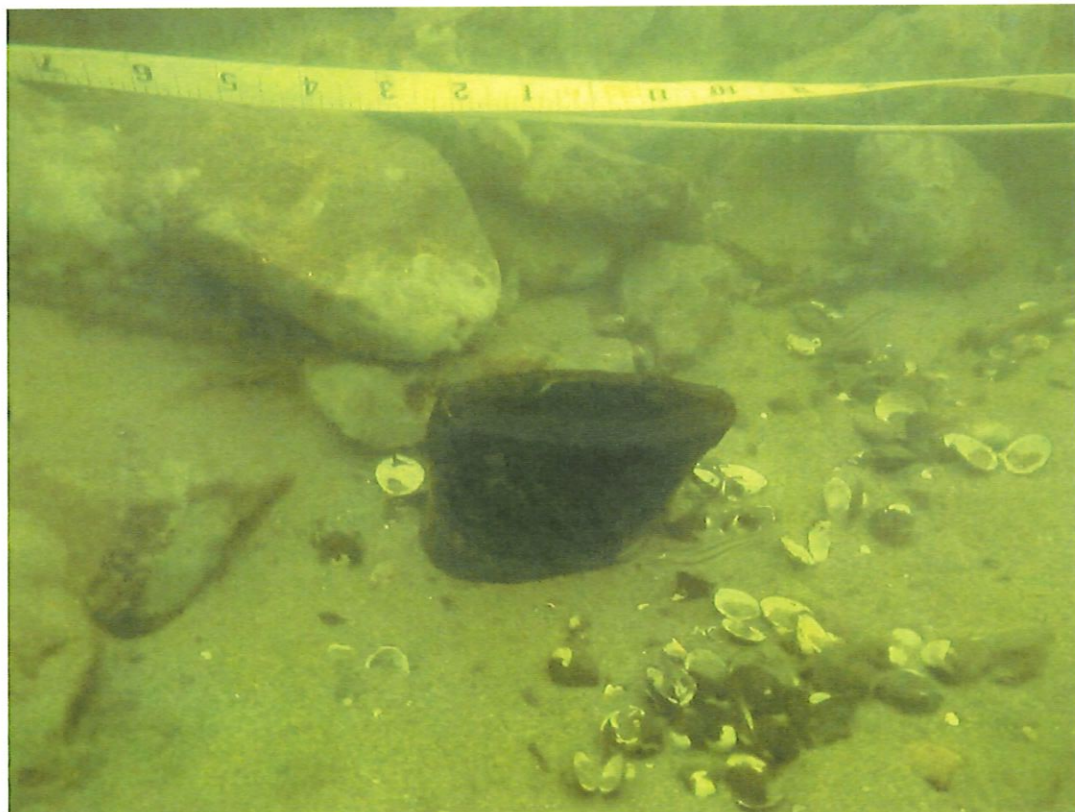
Divers conducted a tactile, visual, and narrated video inspection at all thirty-six (36) diffuser port locations to describe flows and above river bottom grade risers and ports. All were accounted for, in place and found to be in good condition and with no missing fasteners nor apparent damage to the Red Valve ports. At twelve (12) diffuser riser location the upper flange connections were visible and exposed (Diffuser #5 through #12, #20 through #22, and #28). All the fasteners and other visible hardware was tight and in good condition. Riprap was present above the entire diffuser section and around all diffusers. Sand levels exceeded the height of the riprap in locations with diffusers 14 through 18 protruding 4-inches or less from the sediment.

Photo 8 – Diffuser #16, Post-Cleaning

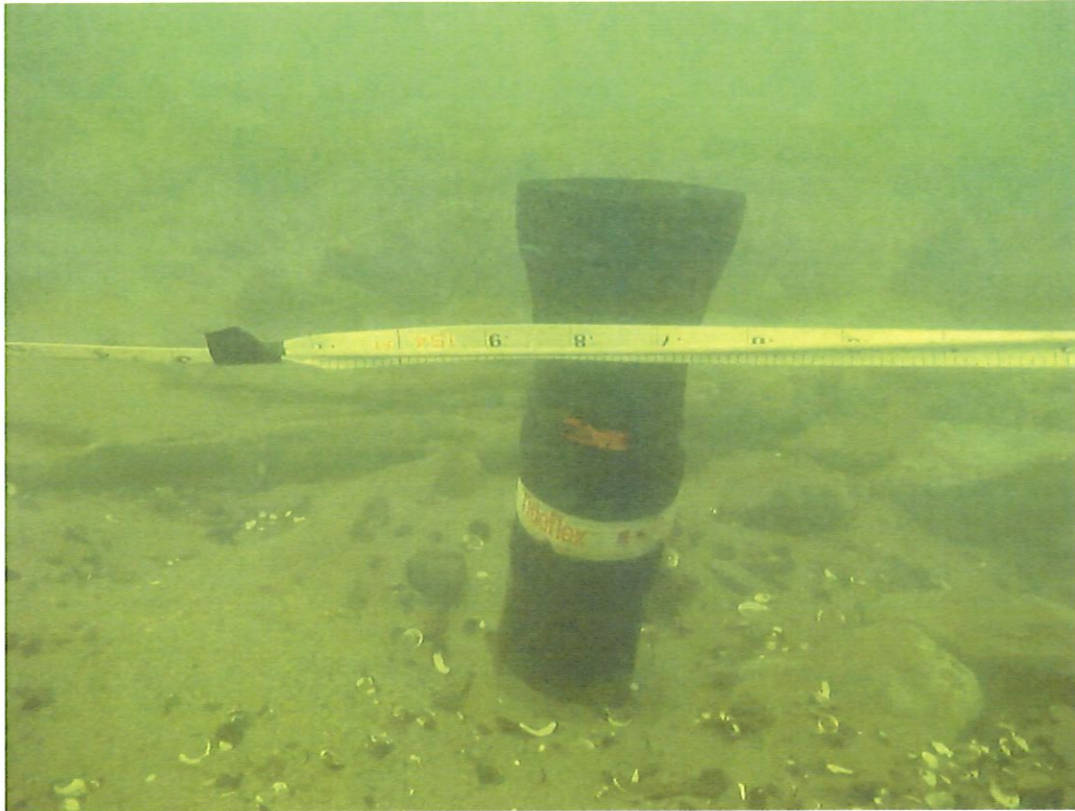
Photo 9 – Diffuser #19, Post-Cleaning

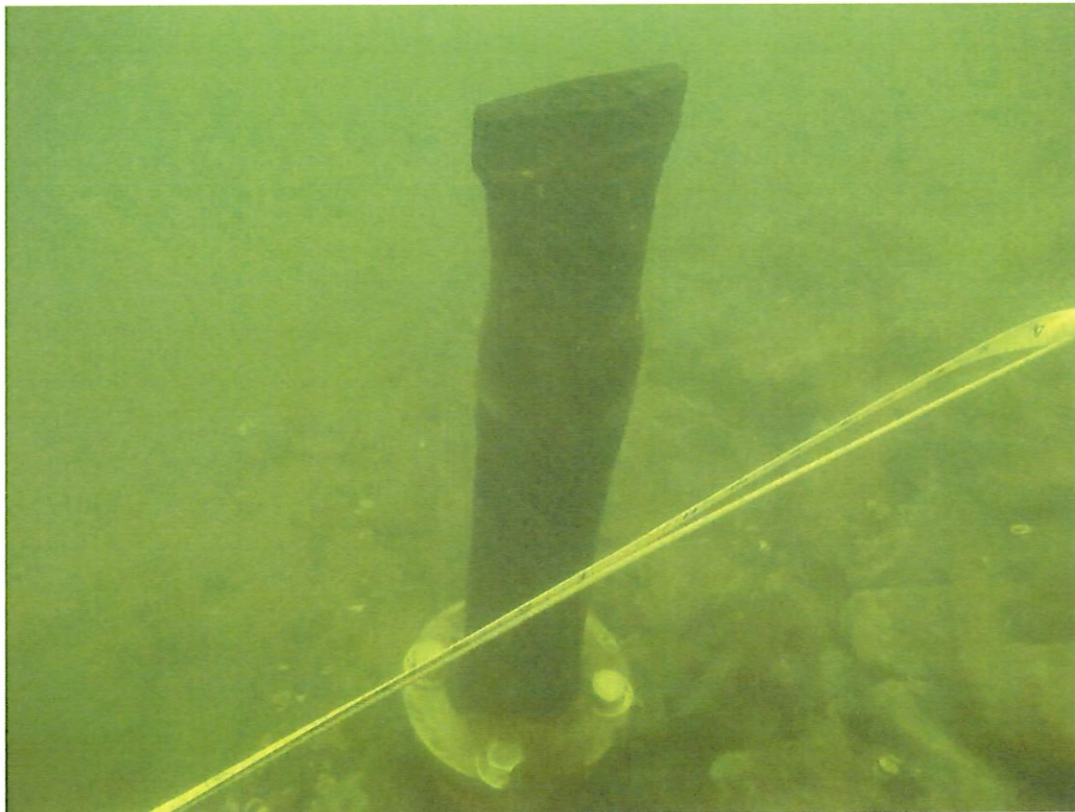
Photo 10 – Diffuser #22, Post-Cleaning

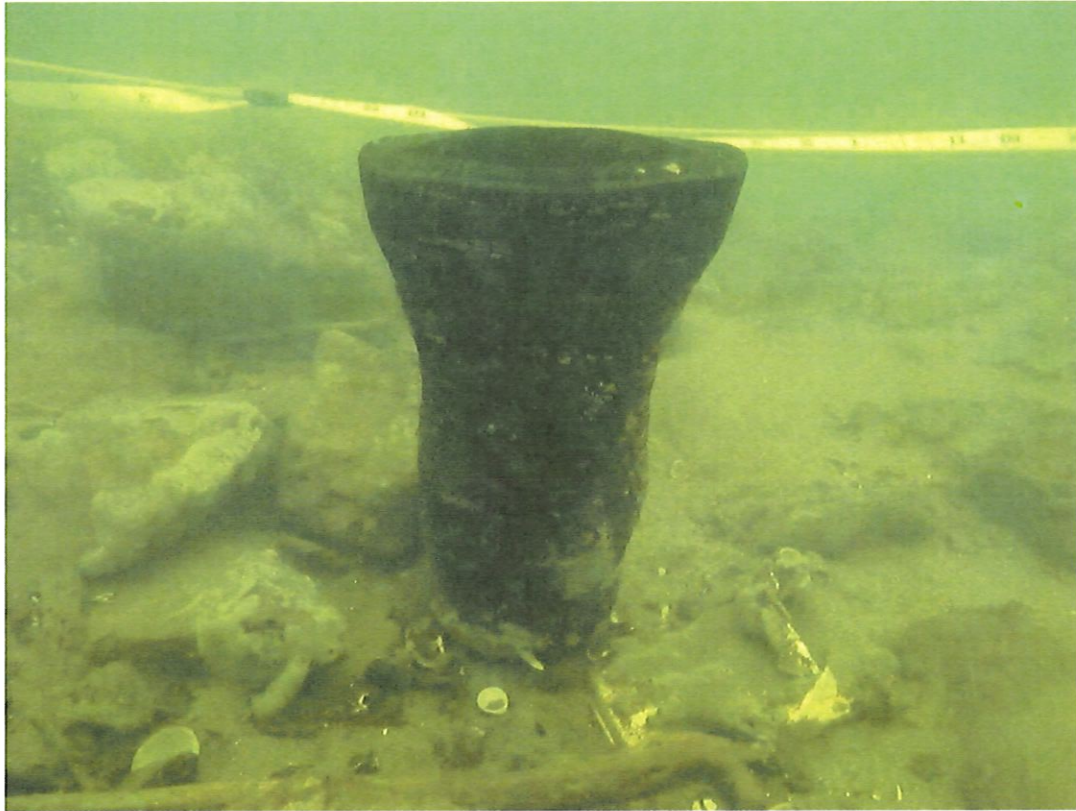
Photo 11 – Diffuser #25, Post-Cleaning

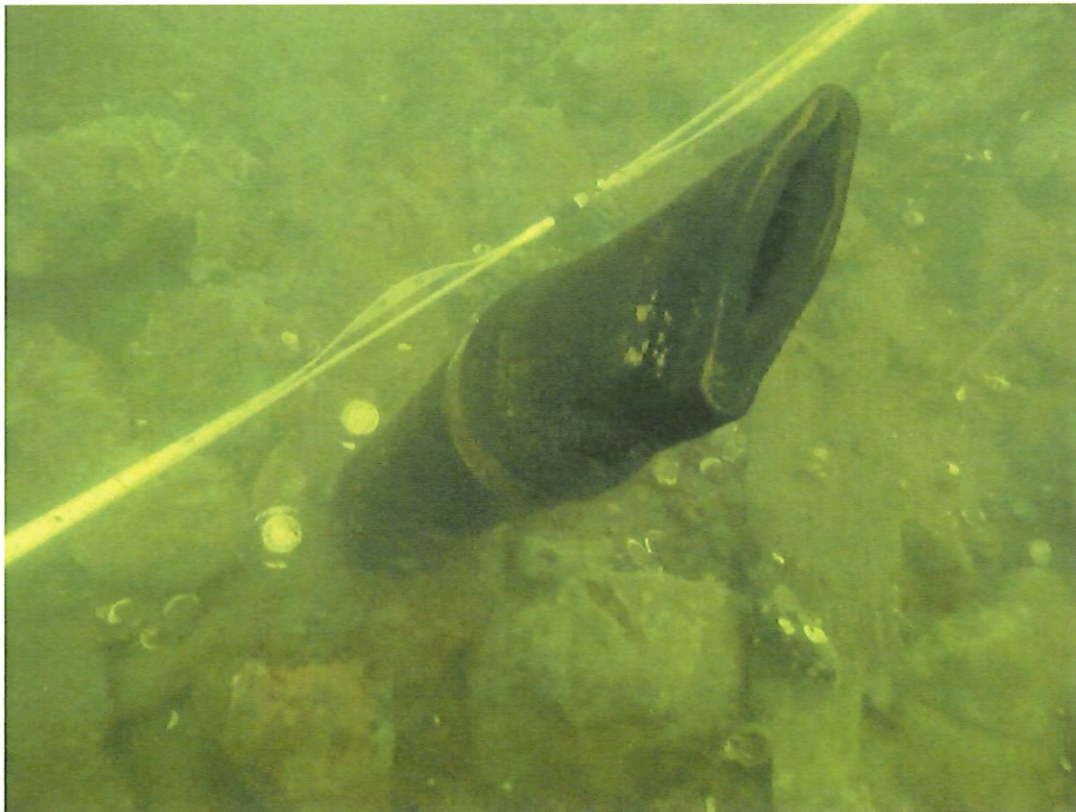
Photo 12 – Diffuser #28, Post-Cleaning

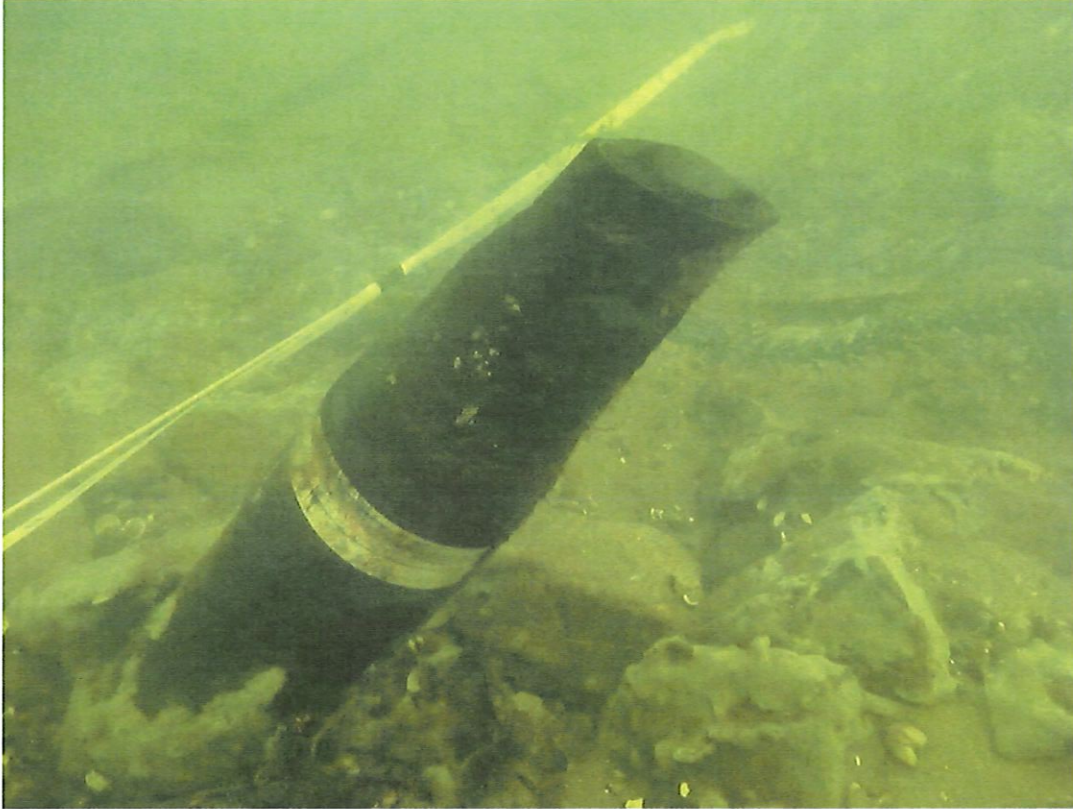
During the initial inspection Diffusers #30 through #32 only had minimal flow and Diffusers #33 through #36 had no flow. The diver used a folding rule to both probe and measure the depth of blockage and point of refusal from within the HDPE diffuser riser through each of these Red Valve rubber ports. After continuing the process of measuring with the folding rule it became apparent to the diver, he could dislodge the internal blockage by performing more rigorous and repeated probing at each location.

Photo 13 – Diffuser #31, Post-Cleaning

The process of probing allowed internal blockage of sediment and shells to be broken up and expelled from the clogged diffusers and, after repeated probing, Diffusers #30 through #36 were all cleaned of debris and had good flow. These efforts can be viewed in the videos titled "[221014 - 1217-1247hrs - Internal Cleaning of Diff. 36-31](#)" and "[221014 - 1247-1300hrs - Internal Cleaning of Diff. 36-31](#)".

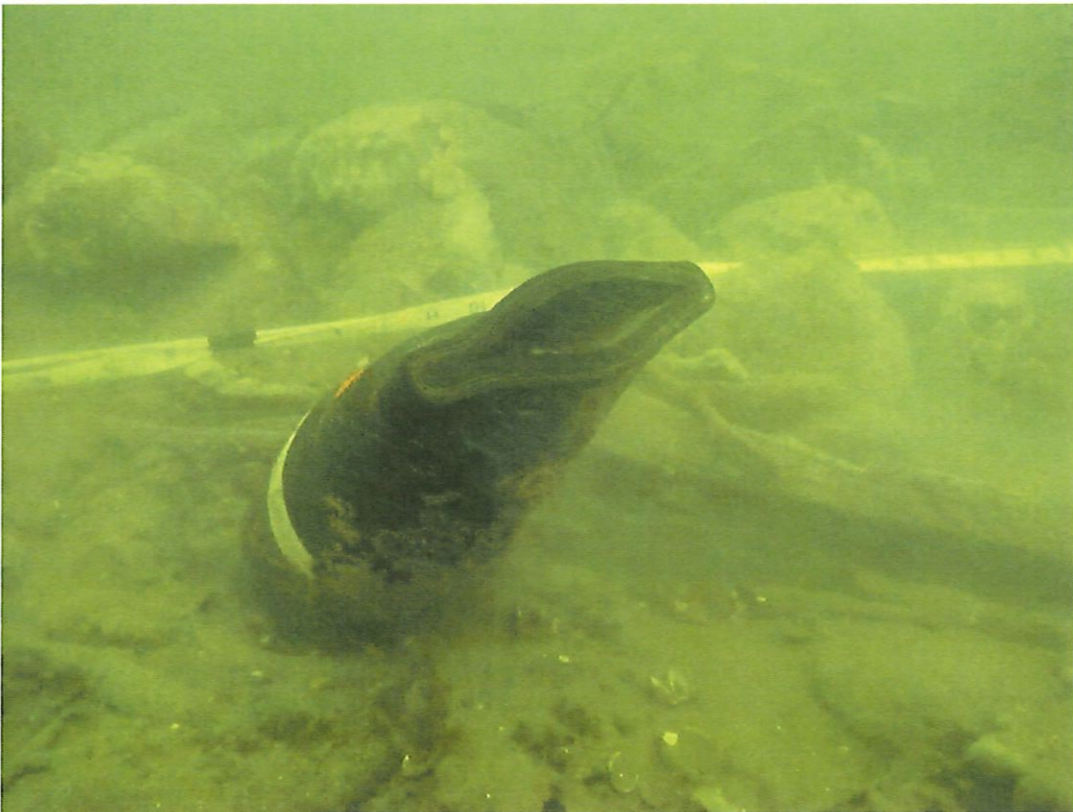
Photo 14 – Diffuser #35, Post-Cleaning
