PROPERTY CONDITION REPORT

Town of Discovery Bay Community Center Pool
1800 Willow Lake Road
Discovery Bay, CA 94505
February 15, 2019
Terracon Project No. BE186102

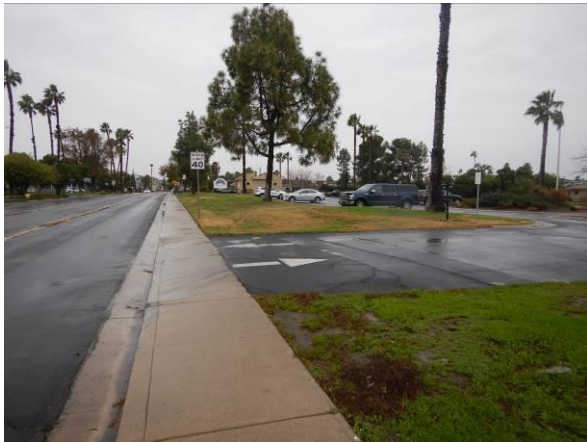
Photo #1 Vehicular access is provided by drive lane entrances off of Willow Lake Road.

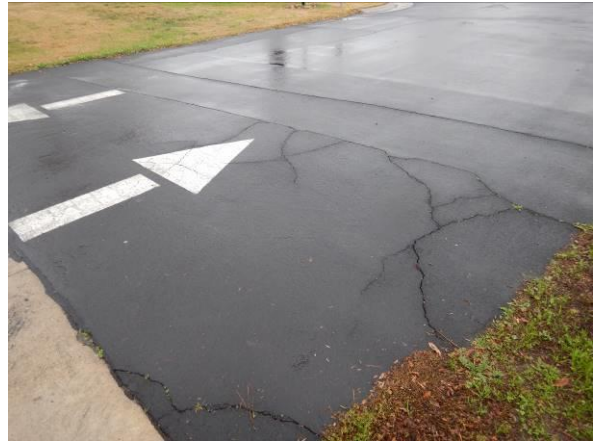
Photo #4 Longitudinal and transverse cracking was observed throughout asphaltic pavements.

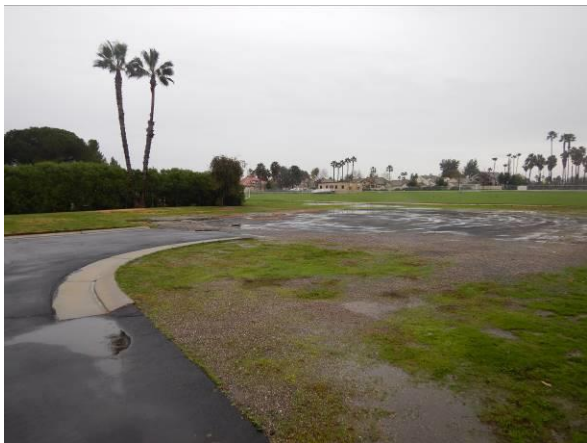
Photo #5 Overview of open green space provided along the south property boundary.

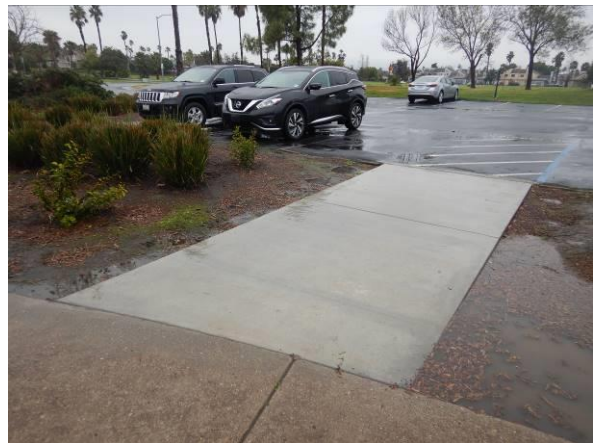
Photo #6 Typical concrete pavements.

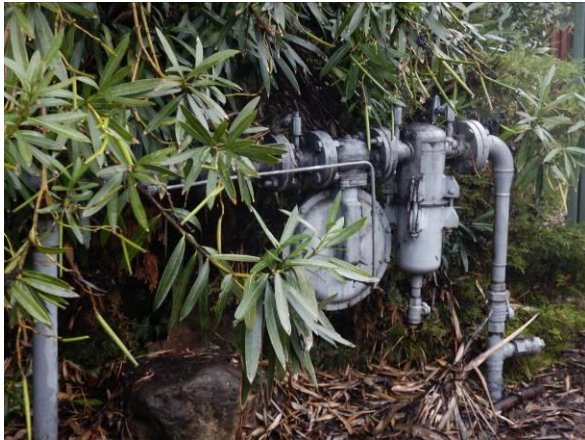
Photo #7 Natural gas meter and service and to the building. Note seismic shutoff provisions are not installed

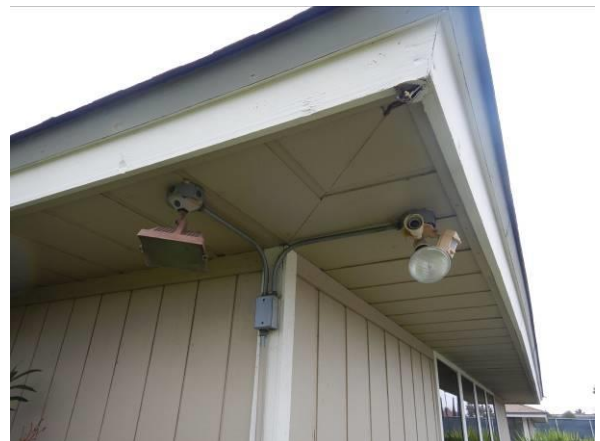
Photo #12 Building-mounted light fixtures.

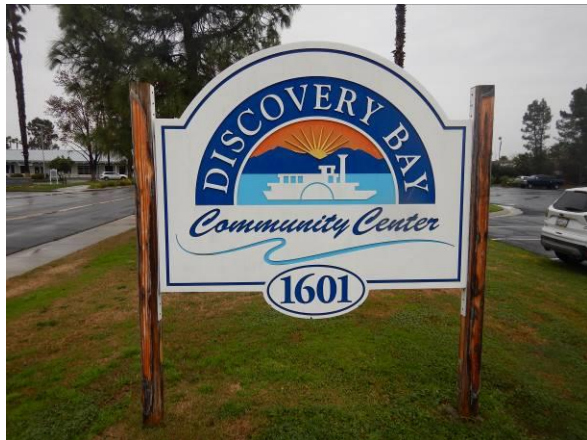
Photo #13 Monument signage is located adjacent to the entrance drives.

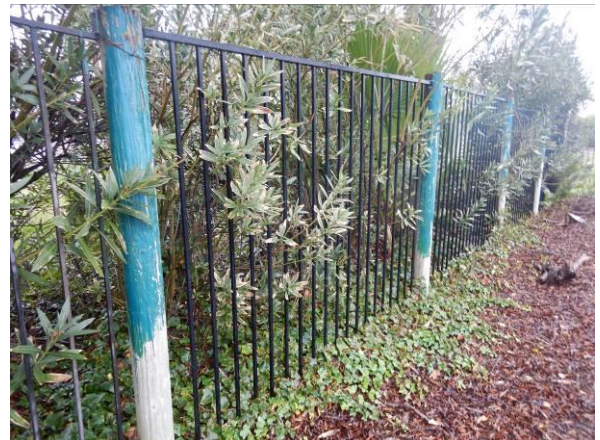
Photo #14 Painted metal fencing with wood posts are provided at limited sections along the west side of the building. Note deteriorated paint.

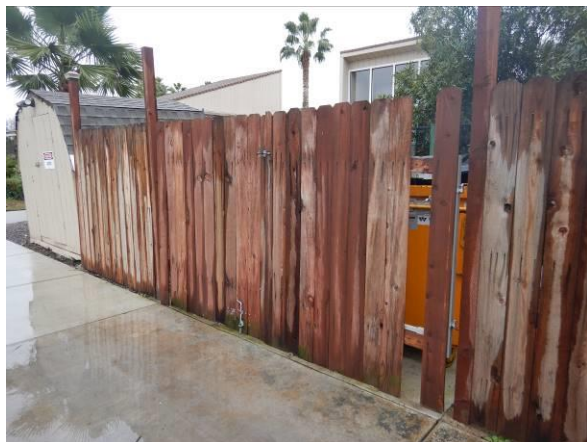
Photo #15 Wood fencing encloses the dumpster area located at the north side of the building.

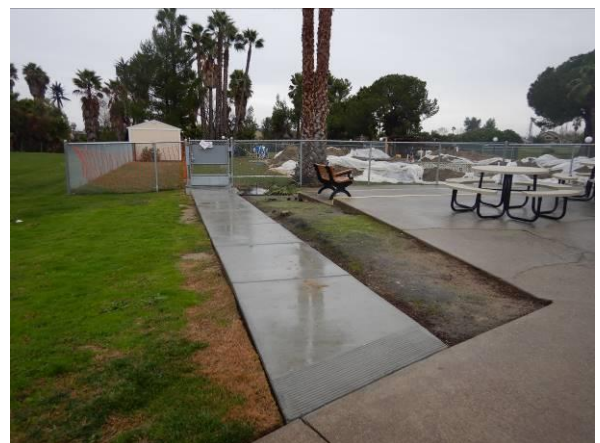
Photo #18 Chain-link fencing temporarily encloses the pool area currently under construction.

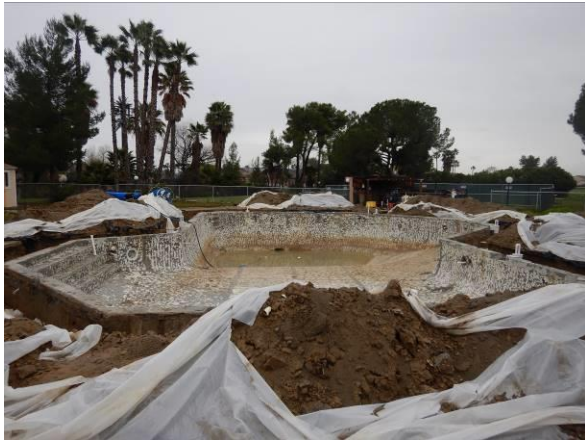
Photo #19 The swimming pool area was in the process of undergoing improvements.

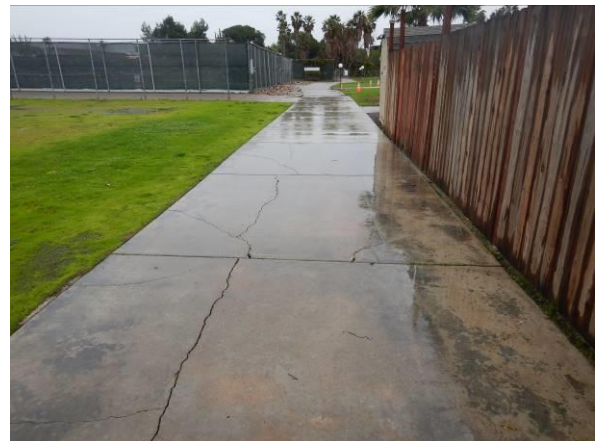
Photo #24 Linear cracking observed at concrete pavements.

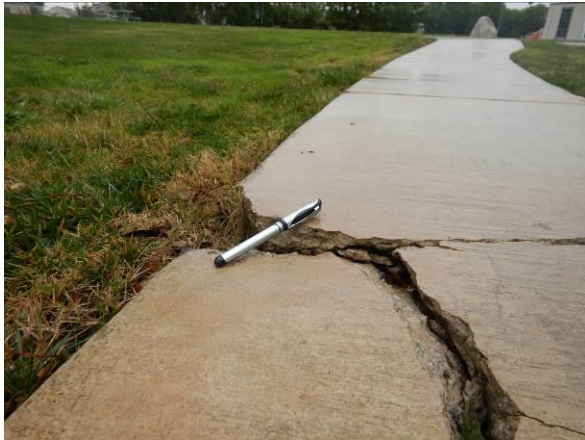
Photo #25 Heaved sections of concrete pavements were observed along the east side of the building. Pen for scale.

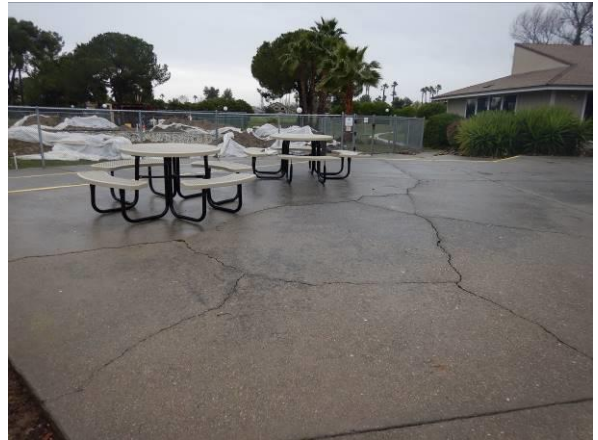
Photo #26 Seating area at east side of building. Note cracking of concrete pavements.

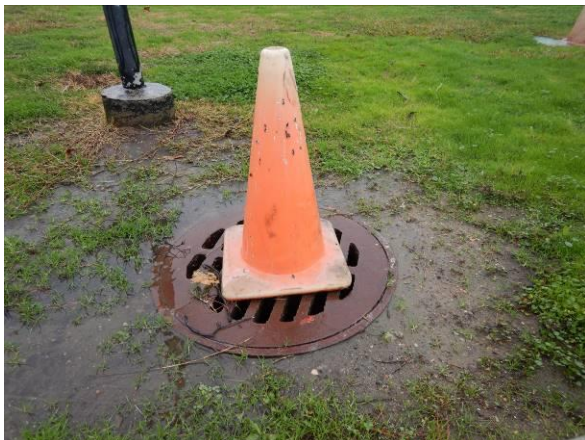
Photo #27 Area drain adjacent to pool area appeared to be clogged at the time of Terracon's site visit.

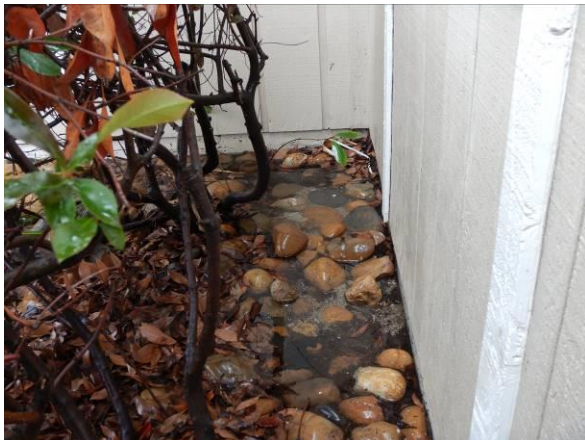
Photo #29 Standing water was observed up against the east side of the building.

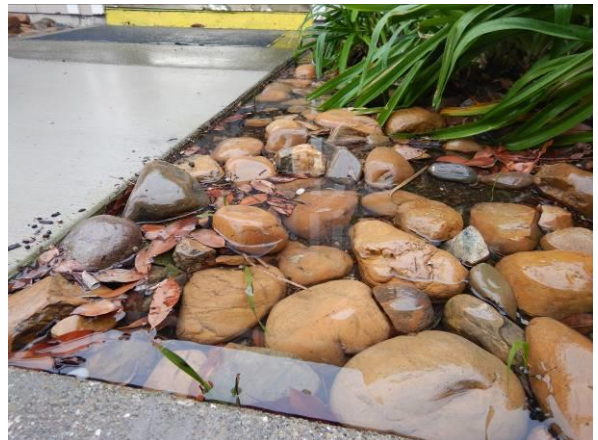
Photo #30 Close-up view of standing water observed in landscaped areas.

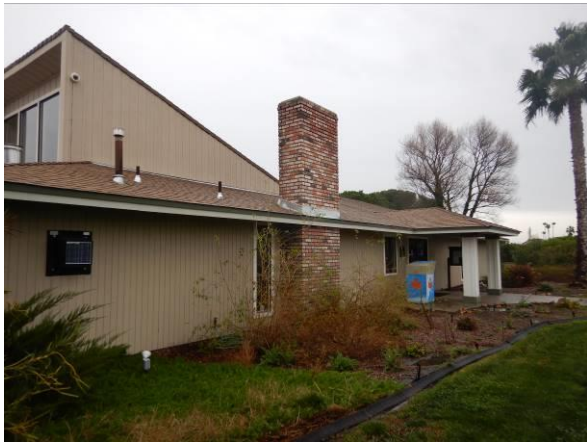
Photo #31 Overview of west building elevation.

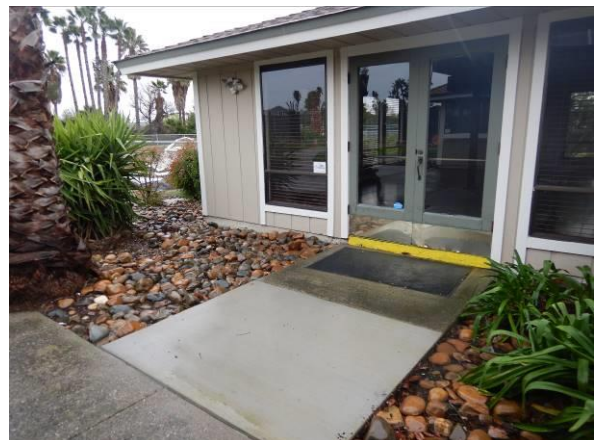
Photo #36 Overview of yoga room exterior entrance.

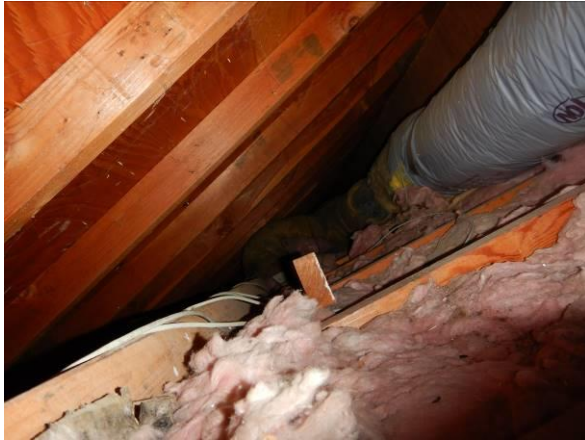
Photo #37 Overview of typical wood-frame building construction, as observed from attic

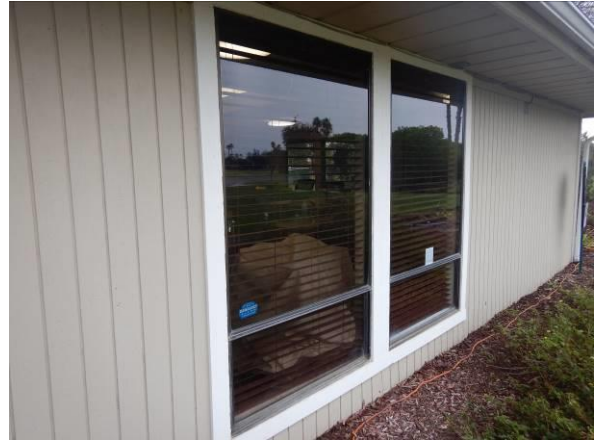
Photo #38 Typical window unit.

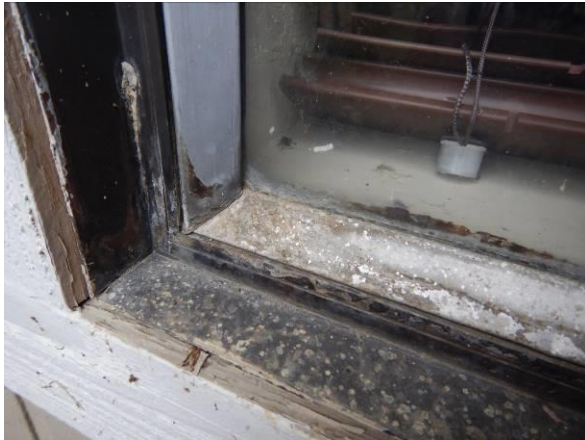
Photo #39 Close-up exterior view of window sill and jamb. Note deterioration of window sealants.

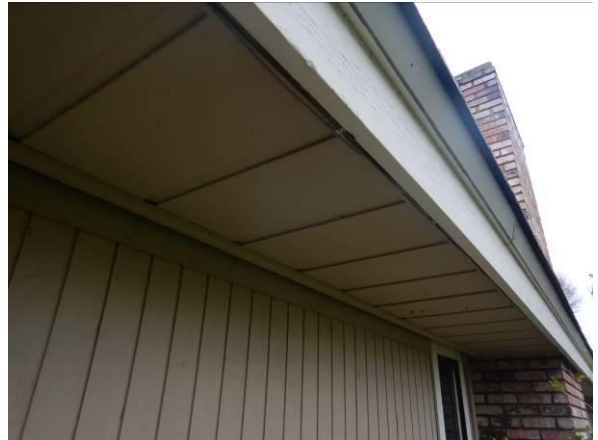
Photo #40 Building exterior walls consist of painted wood siding with metal accents.

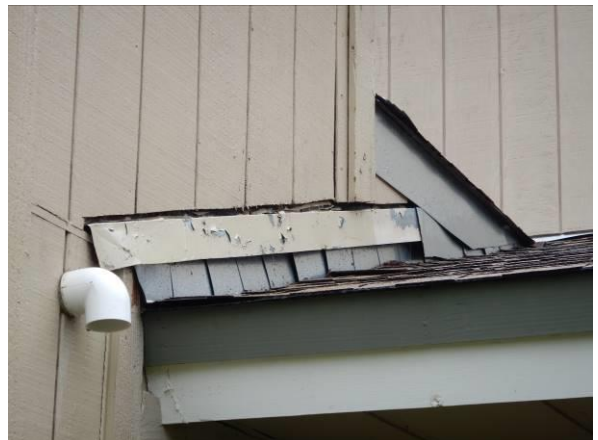
Photo #42 Localized areas of delaminated paint were observed at metal trim and roof flashings.

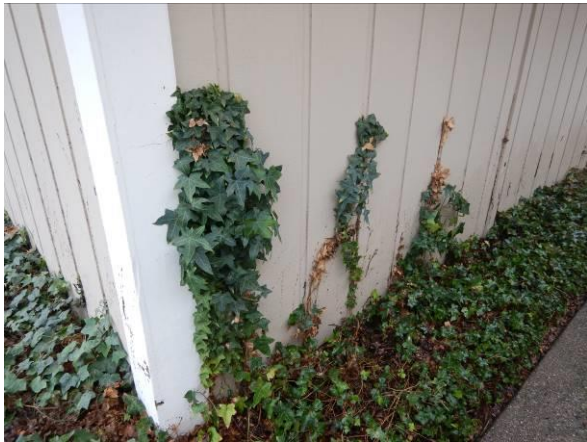
Photo #43 Biological growth was observed at localized areas of the building exterior.

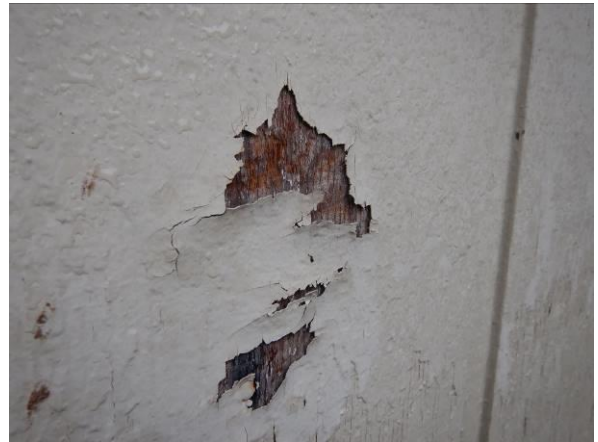
Photo #44 Example of paint damage and deterioration observed in localized areas throughout the building exterior.

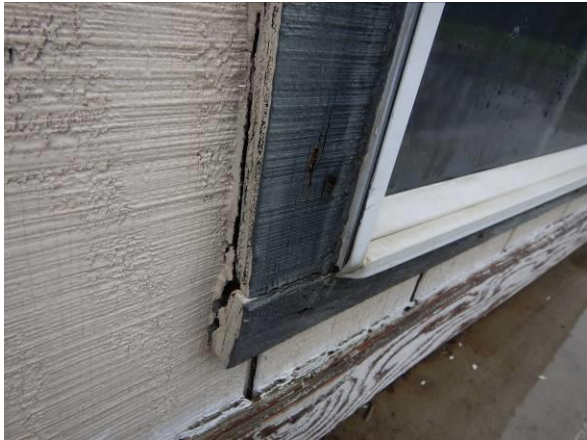
Photo #45 Deteriorated sealants were observed at window penetrations.

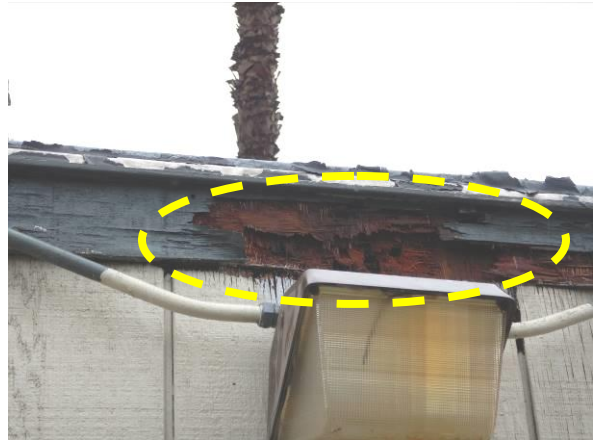
Photo #46 Localized areas of wood decay or otherwise damaged wood trim were observed at the roof edge.

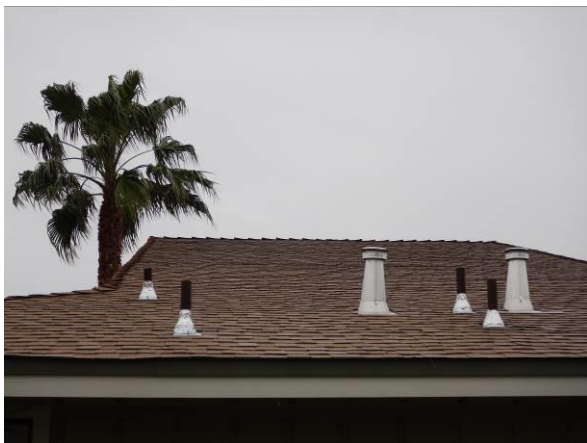
Photo #47 The roof consists of asphaltic composition shingles and skylights.

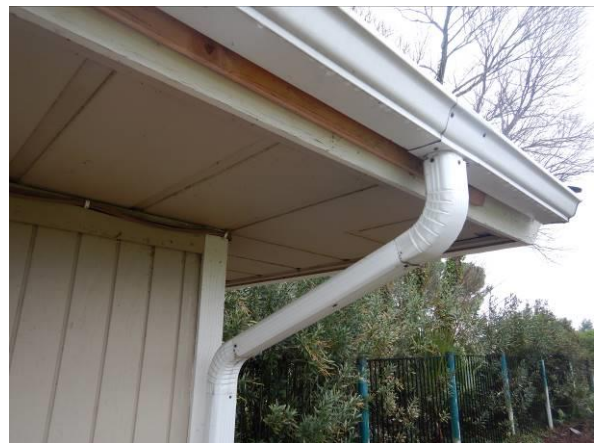
Photo #48 Typical gutter and metal downspout.

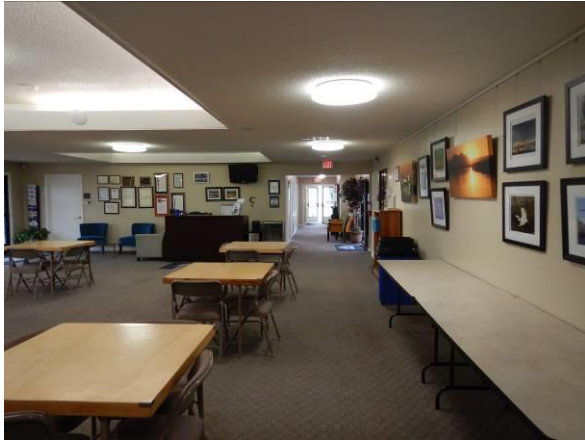
Photo #49 Overview of typical assembly space finishes.

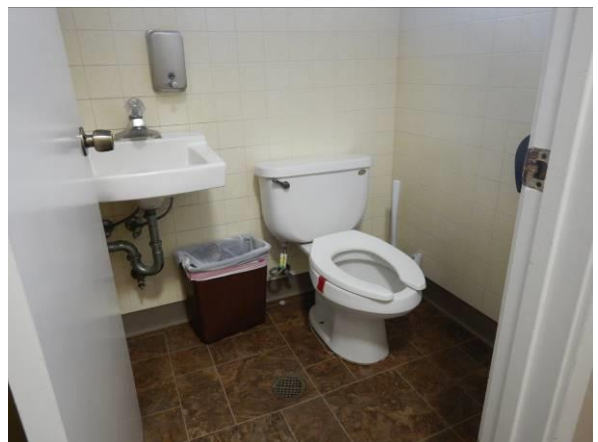
Photo #54 Typical unisex restroom finishes. Note lavatory piping is not protected against contact.

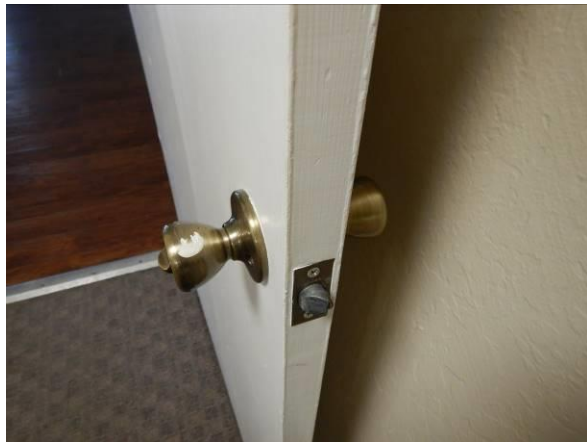
Photo #55 Typical interior door hardware.

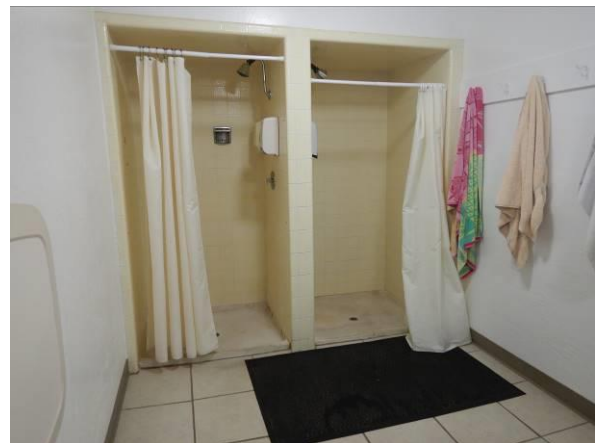
Photo #60 Typical shower entrance in men's restroom. Note that it is not wheelchair accessible. Women's is similar.

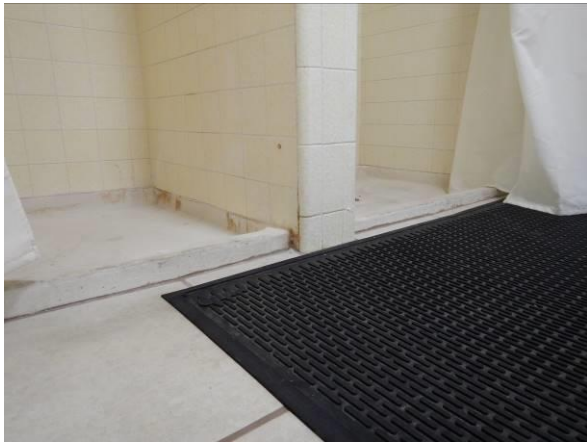
Photo #61 Close-up view of shower entrance threshold. Women's is similar.

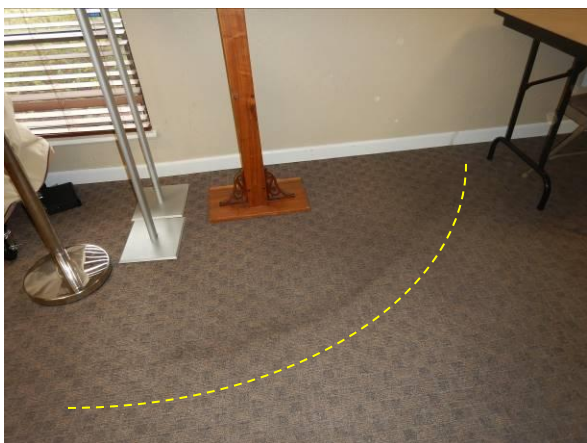
Photo #65 Evidence of what appeared to be past water intrusion was observed along the west interior wall of the assembly room.

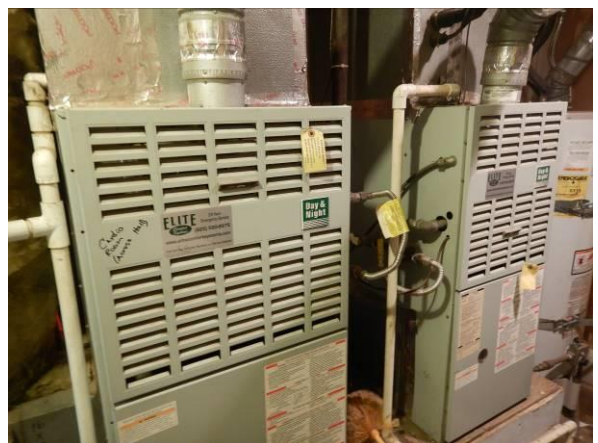
Photo #66 Overview of *Day & Night* natural gas-fired forced-air furnace located in the electrical room.

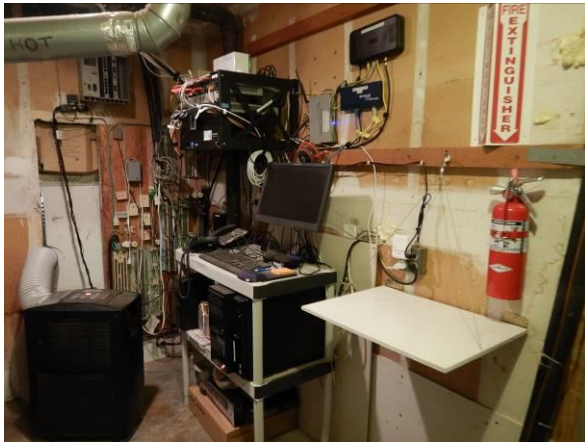
Photo #67 Overview of server area.

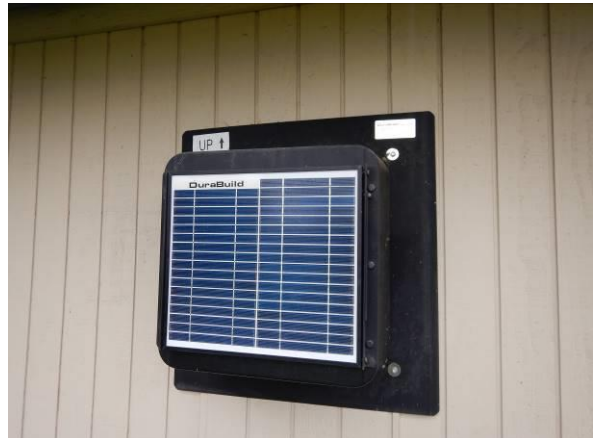
Photo #72 A through-wall, solar-powered fan provides ventilation to the attic.

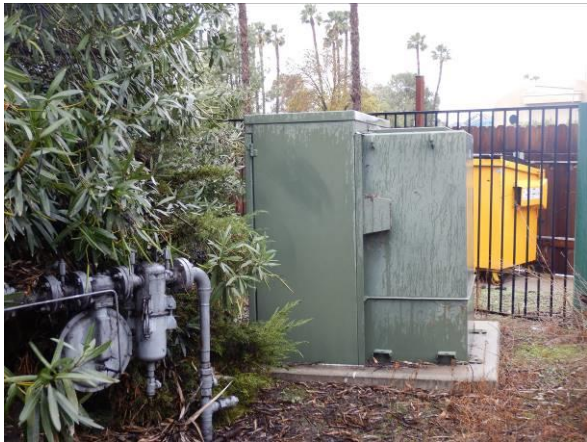
Photo #73 Overview of pad-mounted utility transformer.

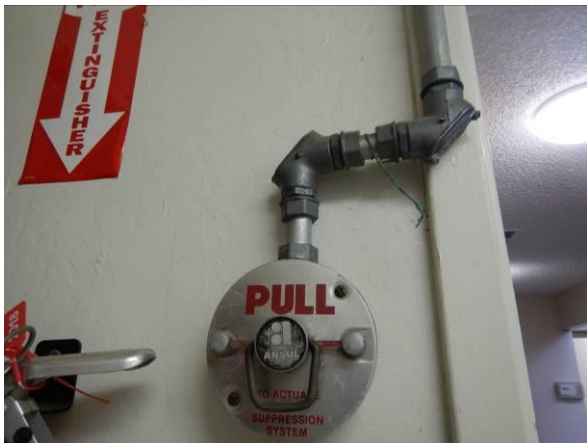
Photo #75 A pull station connected to the Ansul system was observed.

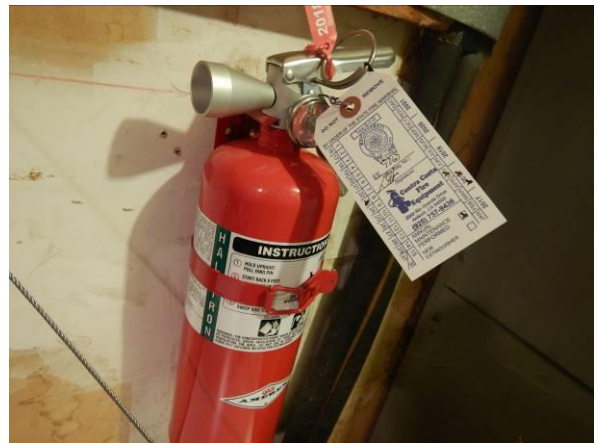
Photo #76 Portable fire extinguishers were observed throughout the property.

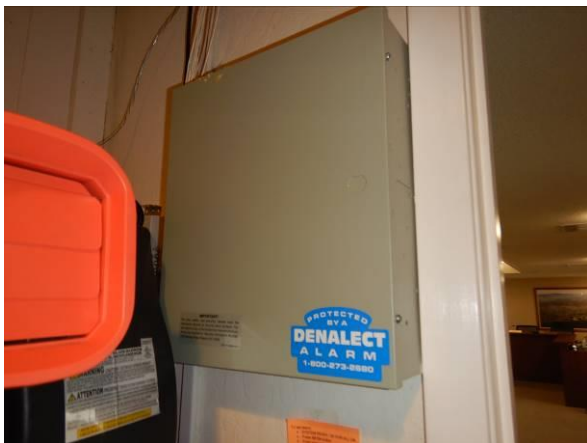
Photo #77 Fire alarm control panel.

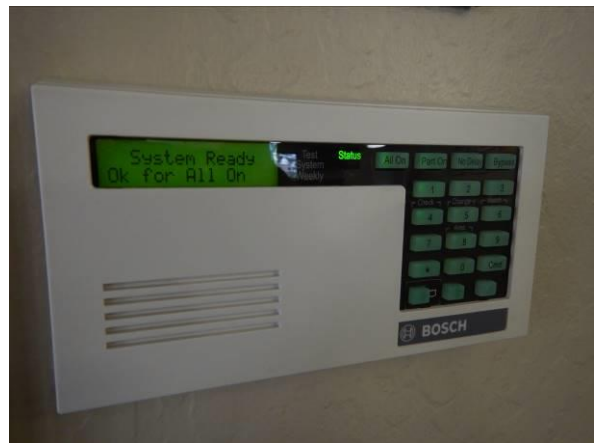
Photo #78 Fire alarm control panel control module.

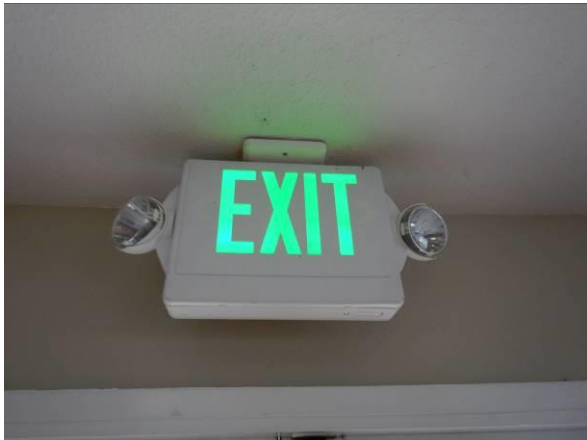
Photo #79 Exit signage is generally provided at exits and along paths of egress.

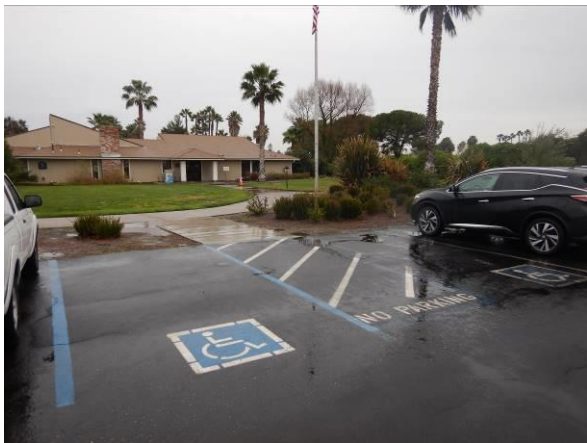
Photo #81 Accessible parking stall. Note missing vertical signage.

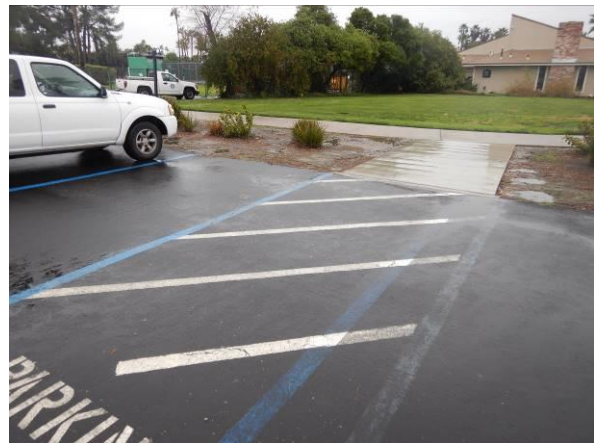
Photo #82 Access aisle.
