# **Water Update**

## ***Overview of Water System & Current Projects***

**Justin Shobe, PE – District Water Engineer**

**June 5, 2019**

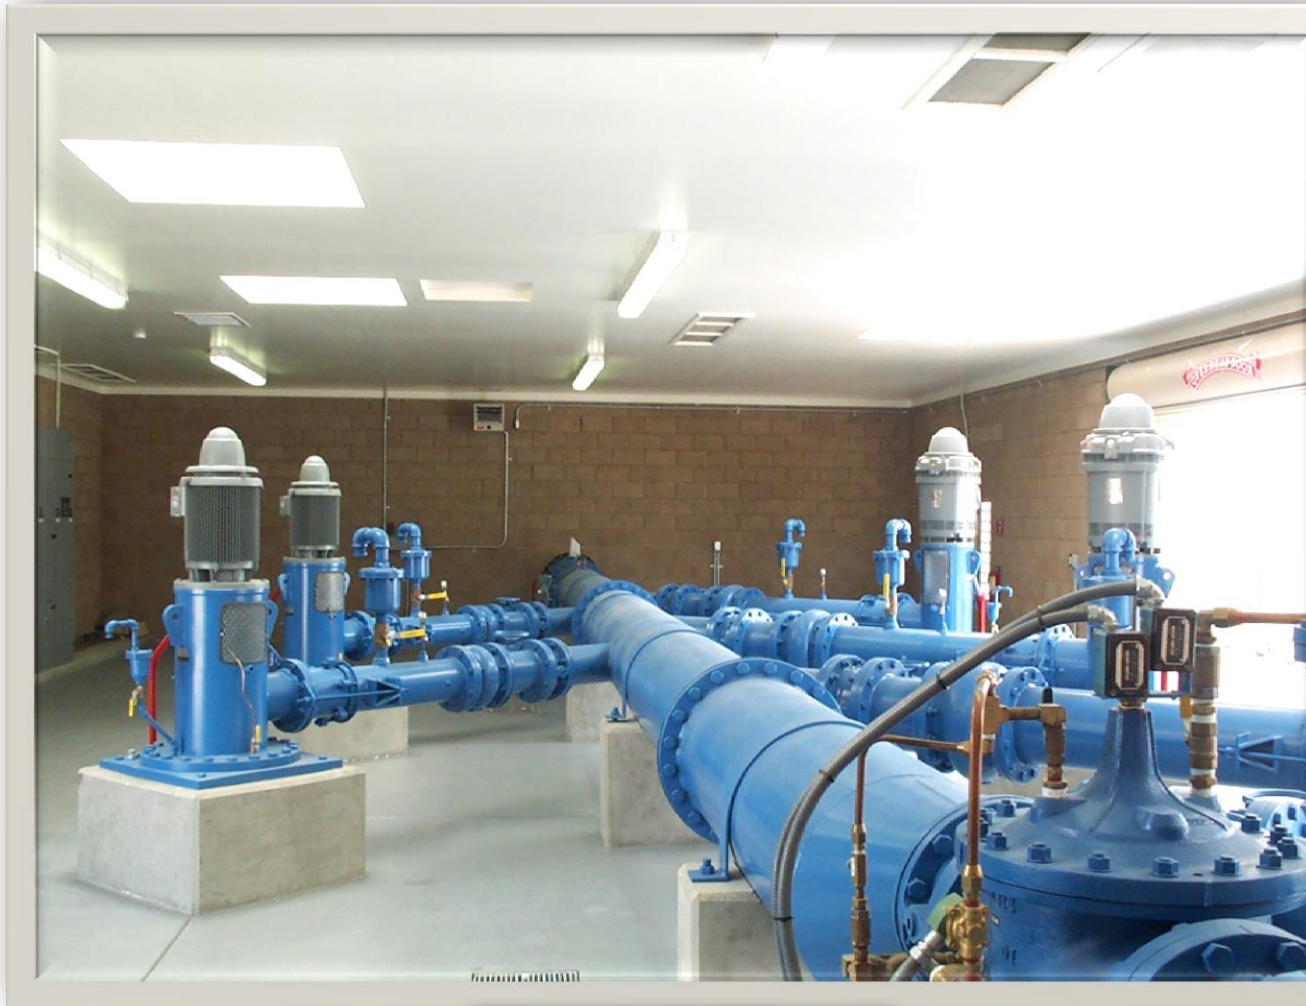
# Water System

## Water System Description

The Town's water is supplied from groundwater aquifers that exist in the earth's crust. There are six wells within the Town that extract groundwater for public consumption. Prior to delivery, the water is treated at two water treatment plants where it is filtered to remove iron and manganese from the water supply for aesthetics, and chlorinated for disinfection.

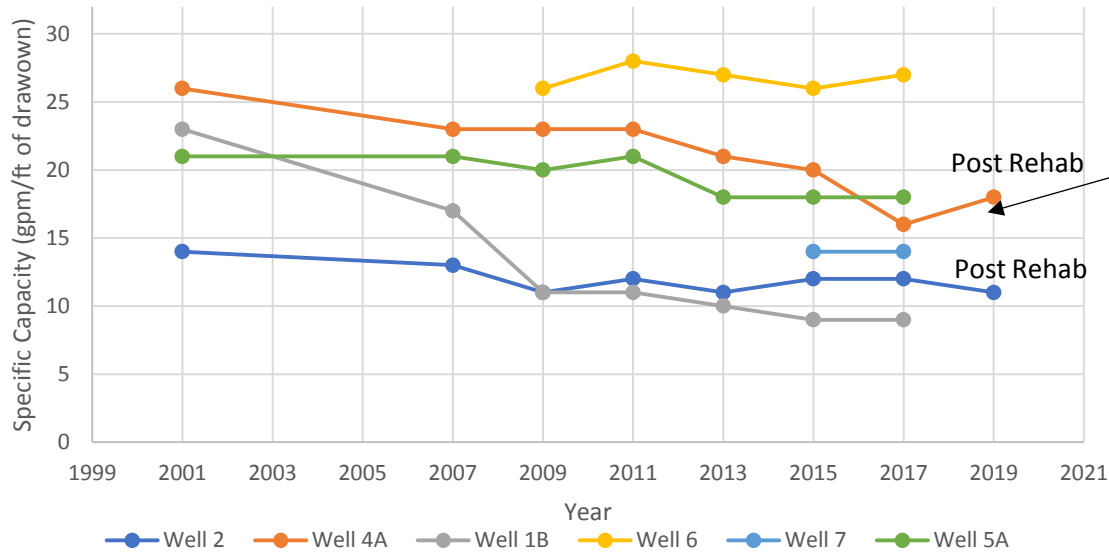
Well Specific Capacity Records

Well 4A had consistent decline, 40% reduction over life. Post-Rehab capacity restored by 10%.

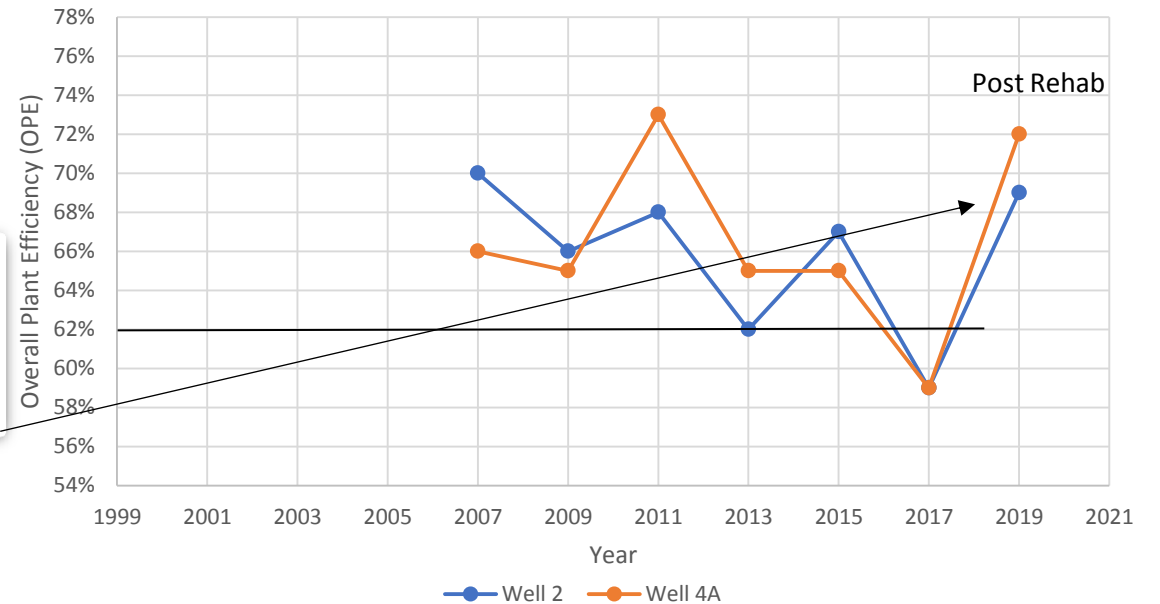
Electrical Efficiency

Well 2 and Well 4A efficiencies dropped below safe levels. Indicates age and wear of pumps. Post-Rehab efficiencies brought to “new pump” conditions.

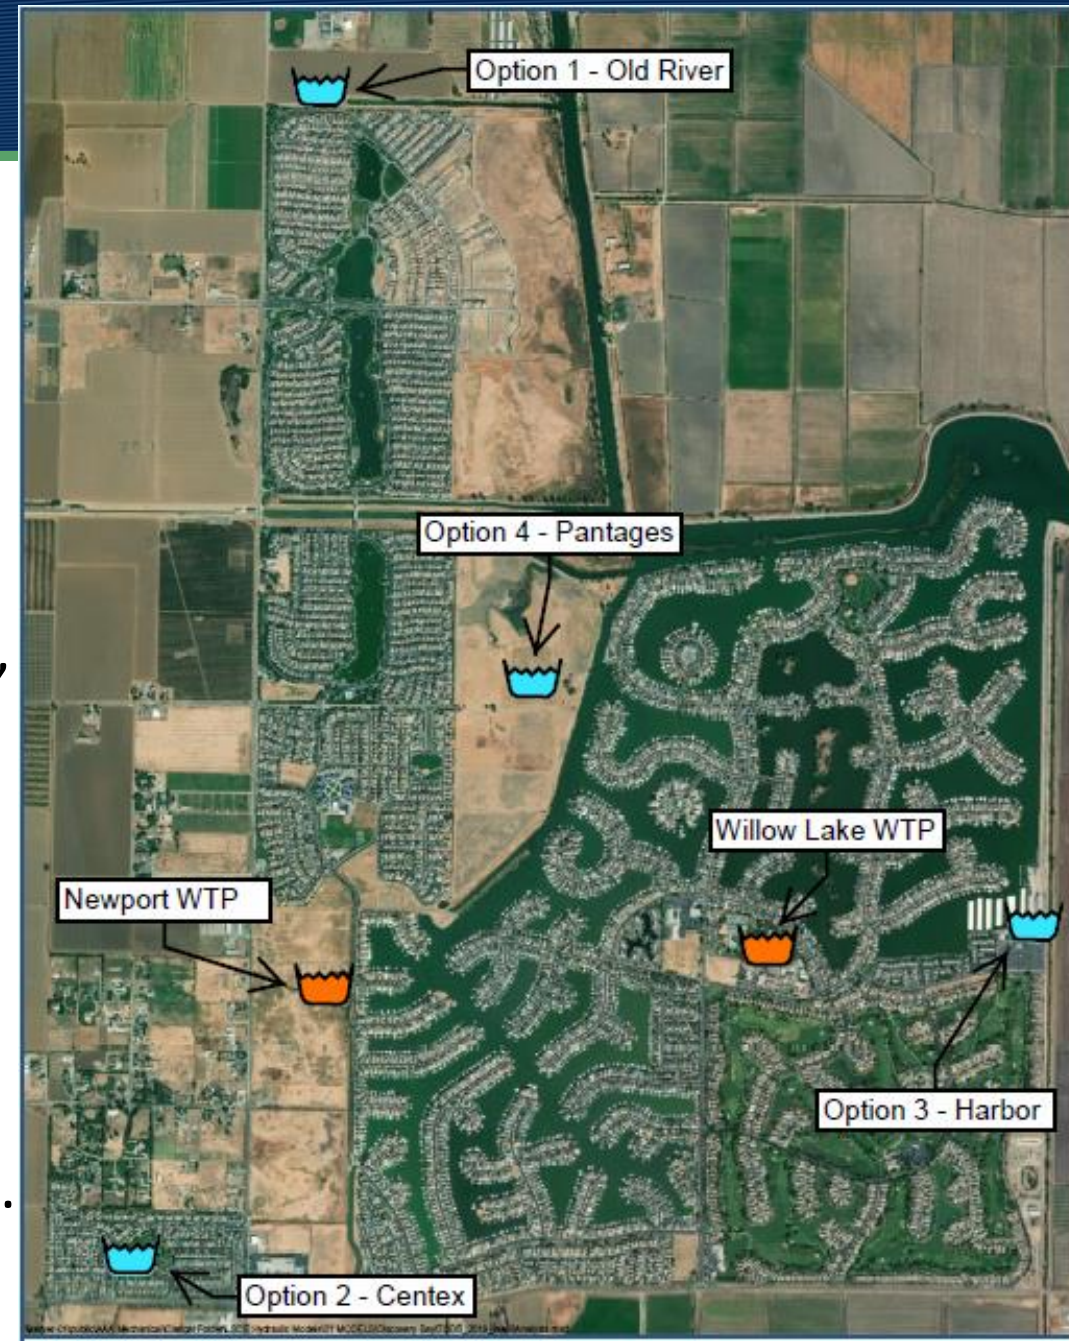
## Well 8 “Stand-Alone” Concept:

- Treats water onsite using a filter.
  - Eliminates the Filter CIP at Willow Lake.
- Delivers straight to the distribution system.
  - Could eliminate the Storage CIP at Newport, (modeling is underway to study this).
- Provides a third source of water to the system.
  - Increases WTP redundancy.
- Anticipating a savings to the current CIP.
  - Cost Estimate feasibility are under investigation.
